<i>Seabed Sampling and Baited Camera Operations</i>	
Vessel	R/V Ocean Veritas
Summary Report Number	08
Operating equipment	MAXI Corer (8 core unit)
Date	05 October 2010
Completed casts (12 hr)	02
Report compiled by	Brian Critchley/Emily Gould

Seabed Sampling Locations

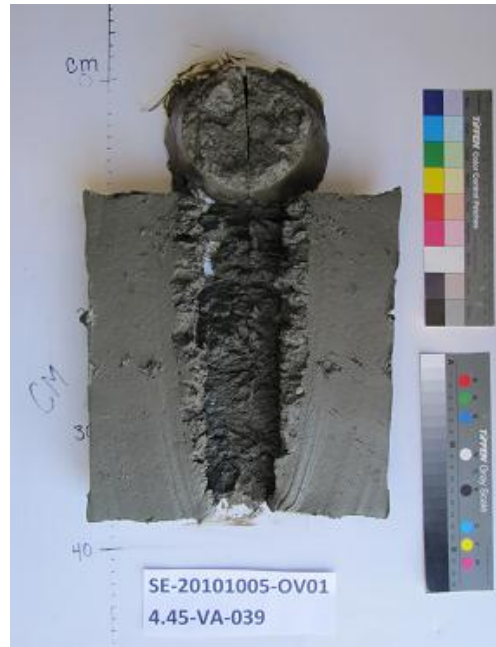
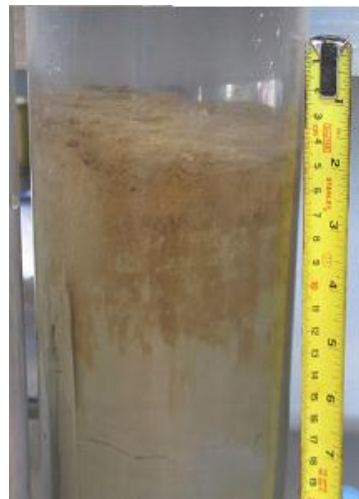
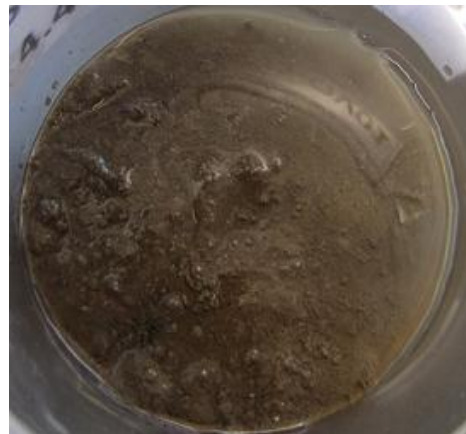
Station 4-45

Recovery: 38 cm

Visible contamination: Yes, sheen on surface.

Description: Dark olive brown fluidized sediment to approximately 2 cm depth. Olive grey, firm, homogenous silty clay. Biota: None.

Top 3 cm removed for GC/MS analysis prior to core extrusion.

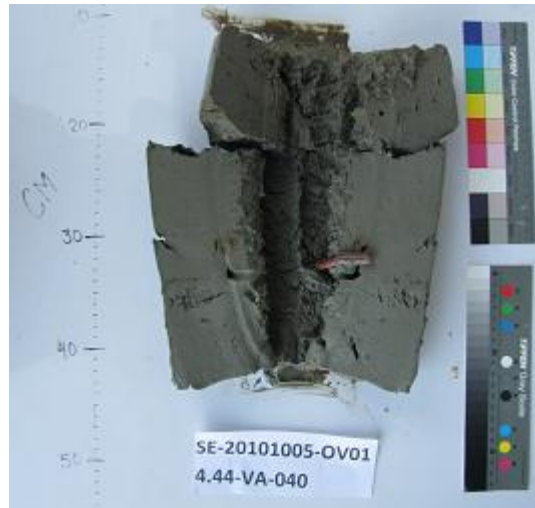
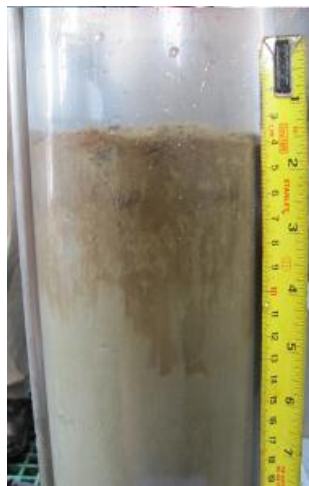
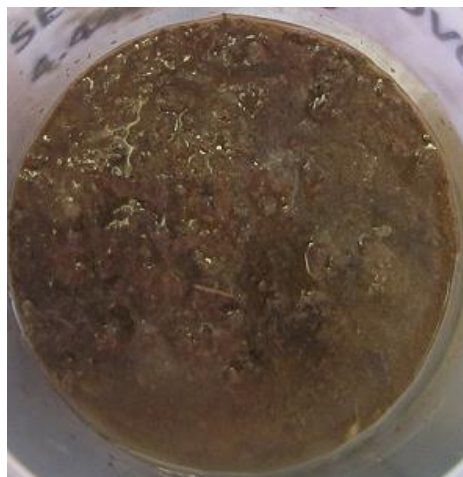
Station 4-44

Recovery: 33 cm

Visible contamination: Yes, sheen on surface.

Description: Olive brown fluidized sediment to approximately 2 cm depth. Olive grey, soft, homogenous silty clay, becoming firm/stiff.

Biota: Worms.

Top 3 cm removed for GC/MS analysis prior to core extrusion.
